# ALAKANUK HEALTH CLINIC

## Alaska Rural Primary Care Facility Code and Condition Survey

Final  
July 23, 2001

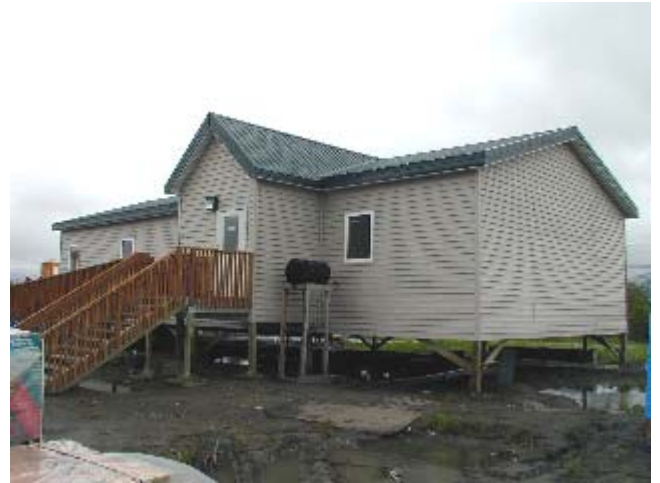
**Exterior from Southeast**

The front stairs and ramp need some completion work and the site needs additional gravel topping to provide for minimal mud entering the facility. There is need for additional office space, itinerant sleeping room, storage and space for itinerant storage as well. The addition of 385 SF would provide these spaces missing in the existing facility.

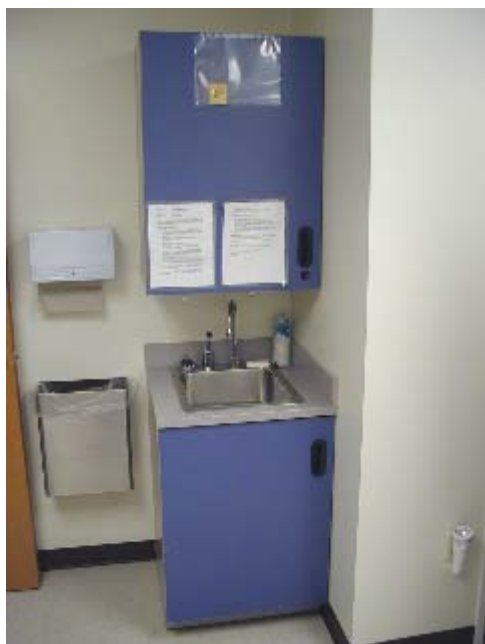
**Exam typical sink and cabinets**

- d. Office/Exam room – There are three smaller exam rooms with very adequate space for normal operation. The sink cabinets have been poorly installed and need adjustment and re-sealing to the walls. The rooms also need privacy curtains or blinds no the windows.

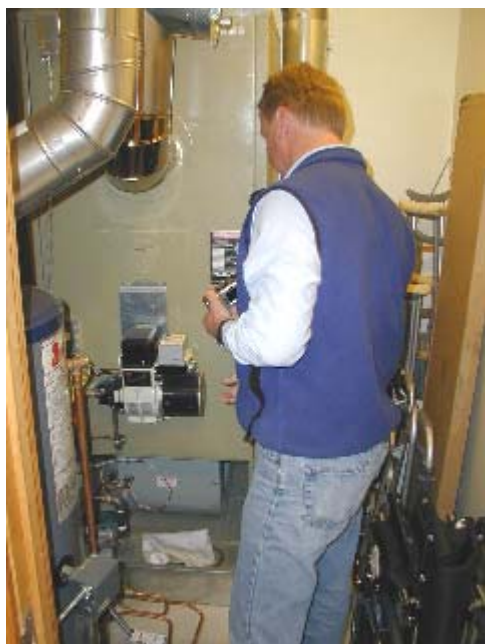
**Mechanical Room**

- c. Furnace  
A single commercial grade, oil-fired furnace provides heating for the entire clinic. The furnace is in good shape with all required controls and a duct system to meet the needs of the Health Clinic. The furnace stack and the vent assembly is in good condition. There is a combustion air opening for the furnace.
